## Analyzing 3370 HDA Damage

Analyzing and determining failure patterns of data check errors that indicate 3370 HDA damage.

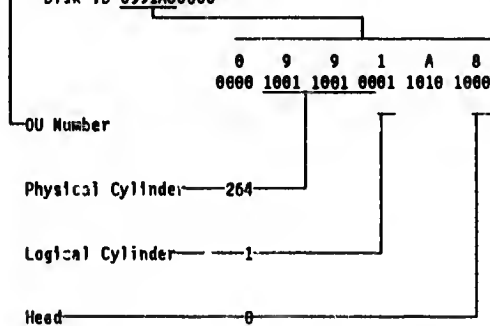
Figure 1. Example of Errors from EREP

Note: The format of the ID shown is for the more common type of errors (603, 609, 616). Use the alternative physical ID format (Ref MLM 51-315) for all other data check errors.

The last FOB indicates the original failing command. The disk ID indicates where the failure actually occurred during error recovery.

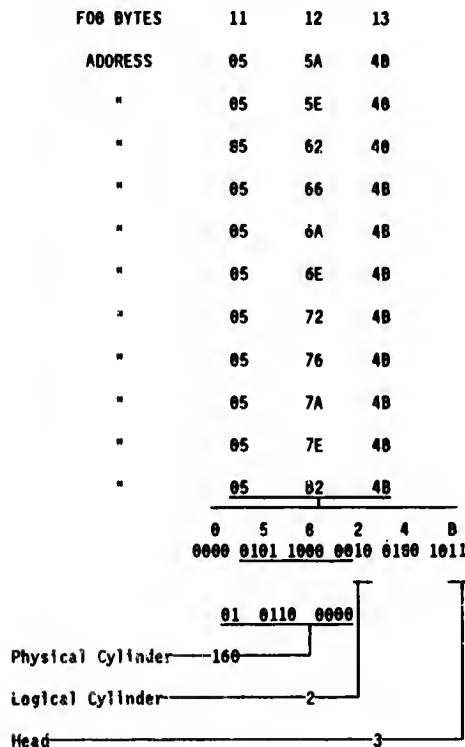
Figure 5. FOB Data Obtained from Pump Scan

When errors at various addresses (Figure 5 on page 4) indicate the same head on the same logical cylinder but different physical cylinders, the problems may be associated with the surface and assignment of alternatives should be considered. If further monitoring indicates damage is continuing, replacement of the HDA should be considered.

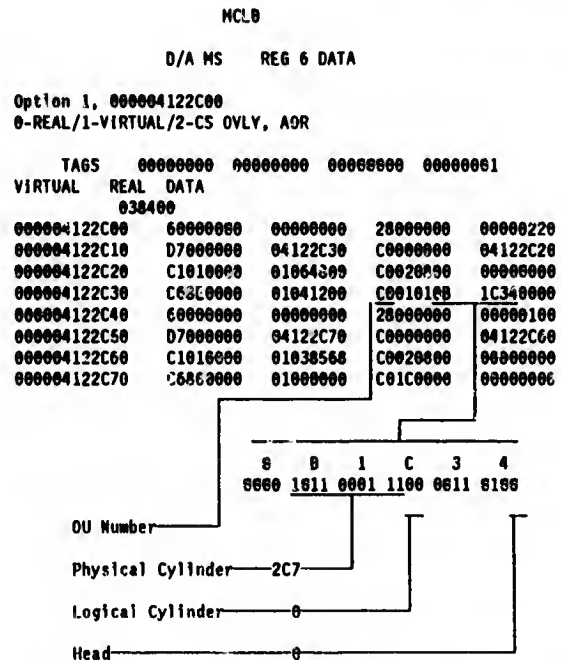
Figure 6. Base Register 6 Failing FOB (MAP Reference 35-150)

If a 5381 service call is originating from an 0818 machine check, always use the address of the failing FOB for determining the OU number, physical cylinder, logical cylinder, and head for pinpointing the failure (Figure 6). This failing address must be used as part of the data for determining failure patterns because it is the location of the error you are trying to correct.
